CORRECTIVE ACTION PLAN
FOR
NORTH CAROLINA DEPARTMENT OF TRANSPORTATION
FORMER ASPHALTIC MATERIALS TESTING LABORATORY SITES
SITE # 6-48 (LEE PAVING)
PITTSBORO, CHATHAM COUNTY, NORTH CAROLINA

S&ME, Inc.
3118 Spring Forest Road
Raleigh, North Carolina 27616
S&ME Project No. 1040-98-107

September 7, 1999

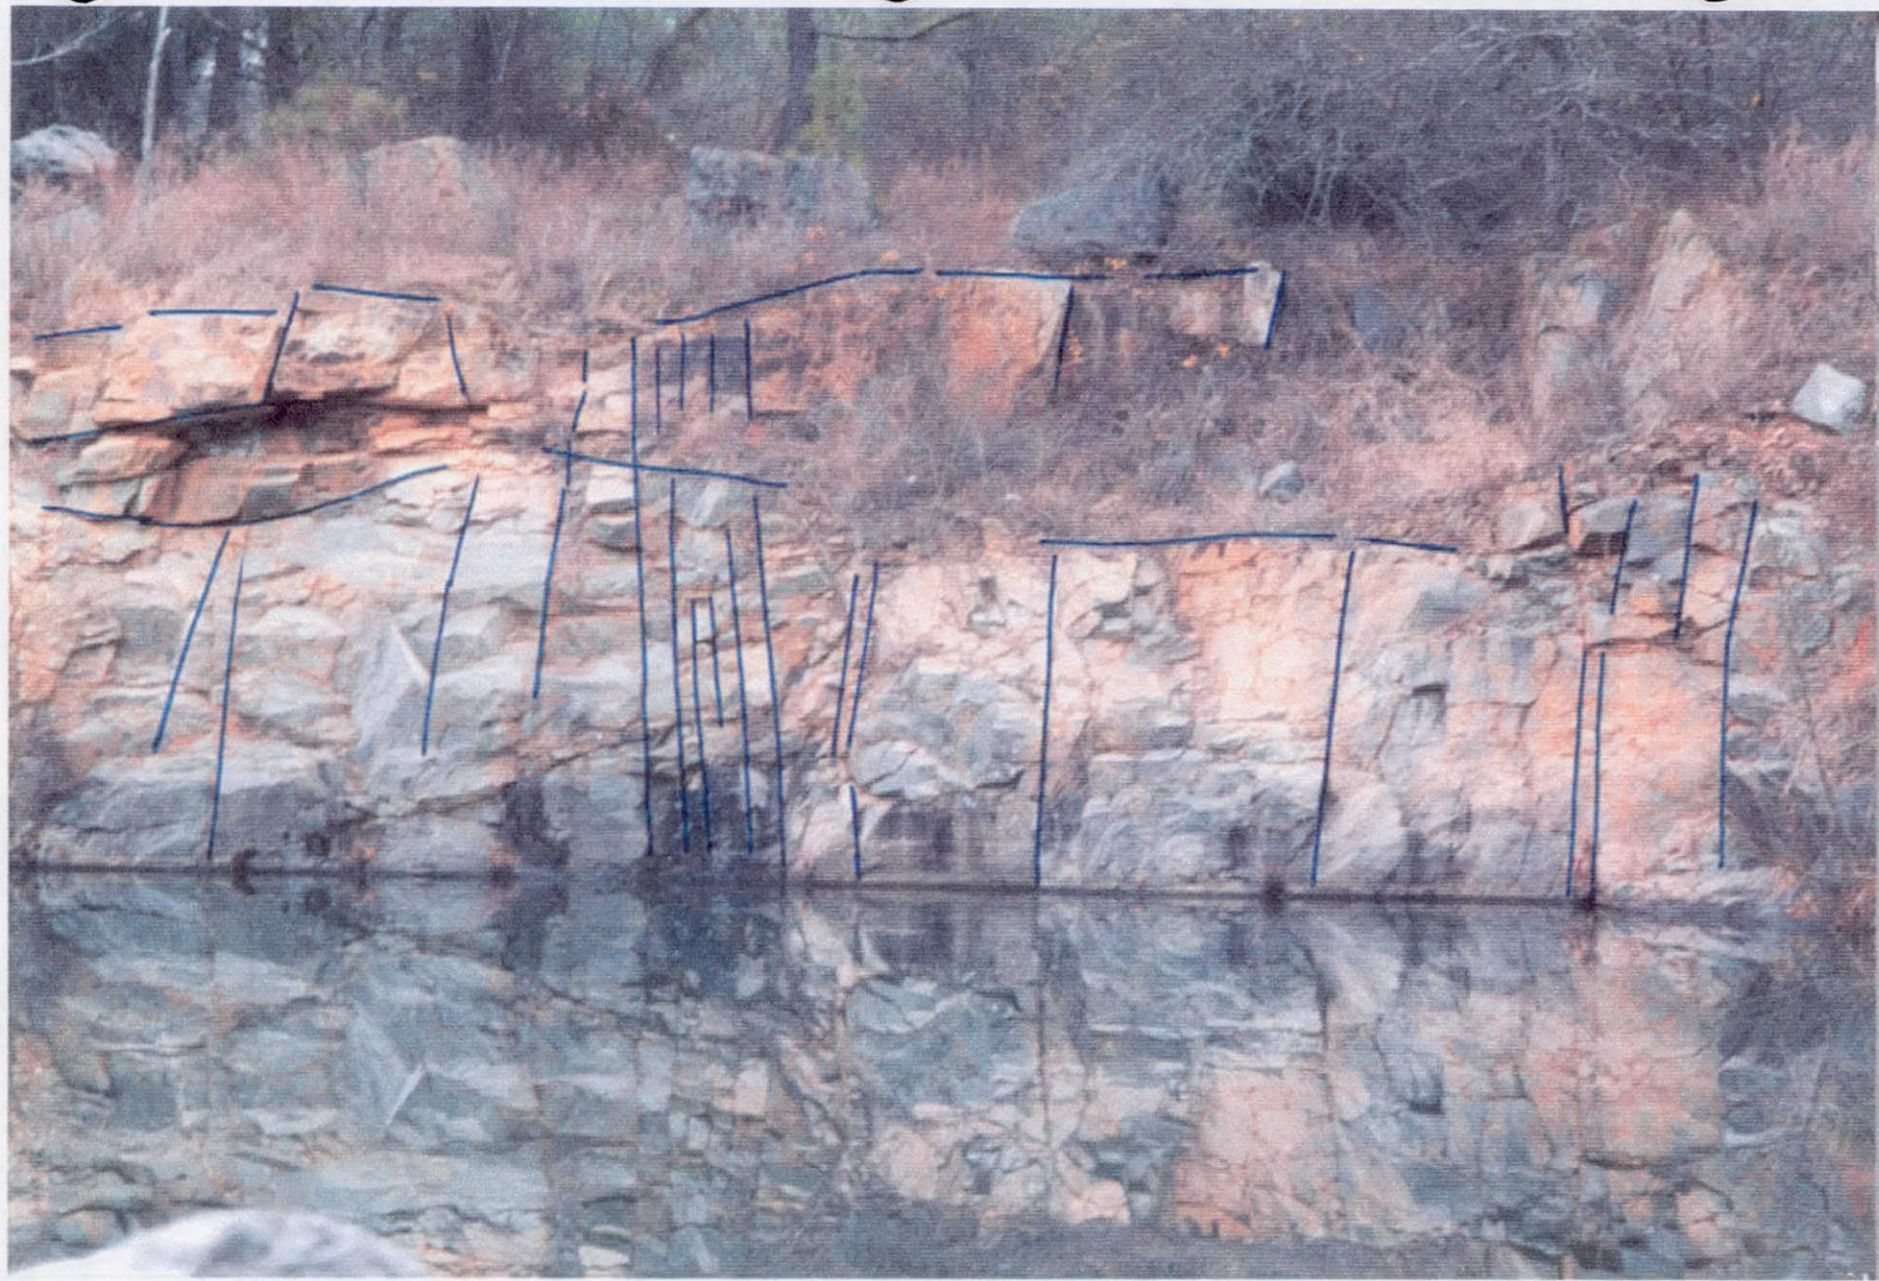
Fig No. 2-2

S&ME mapped bedrock fractures found on one rock outcrop in the creek and, primarily, at the walls of the quarry. Figures 2-2 and 2-3 are photographs of the quarry walls. Figure 2-2 shows the north face of the quarry. Fractures in the photograph are highlighted in blue lines. The reflection in the water surface shows the fractures as they appear unmarked. This photograph shows that there are a number of fairly vertical fractures along with a lesser number of sub-horizontal fractures. The horizontal fractures appear to occur within the transition zone between saprolite and bedrock. Figure 2-2 also shows the variability of fracture density within bedrock. Vertical fracture spacing ranges from approximately 5 to 6 feet along the right side of the photograph to approximately 6 inches in the highly fractured zone just to the left of center. Some seepage is evident from the darker areas of the rock face above the water surface.

BEDROCK FRACTURES
(NORTHERN QUARRY WALL)
NCDOT SITE NO. 6-48

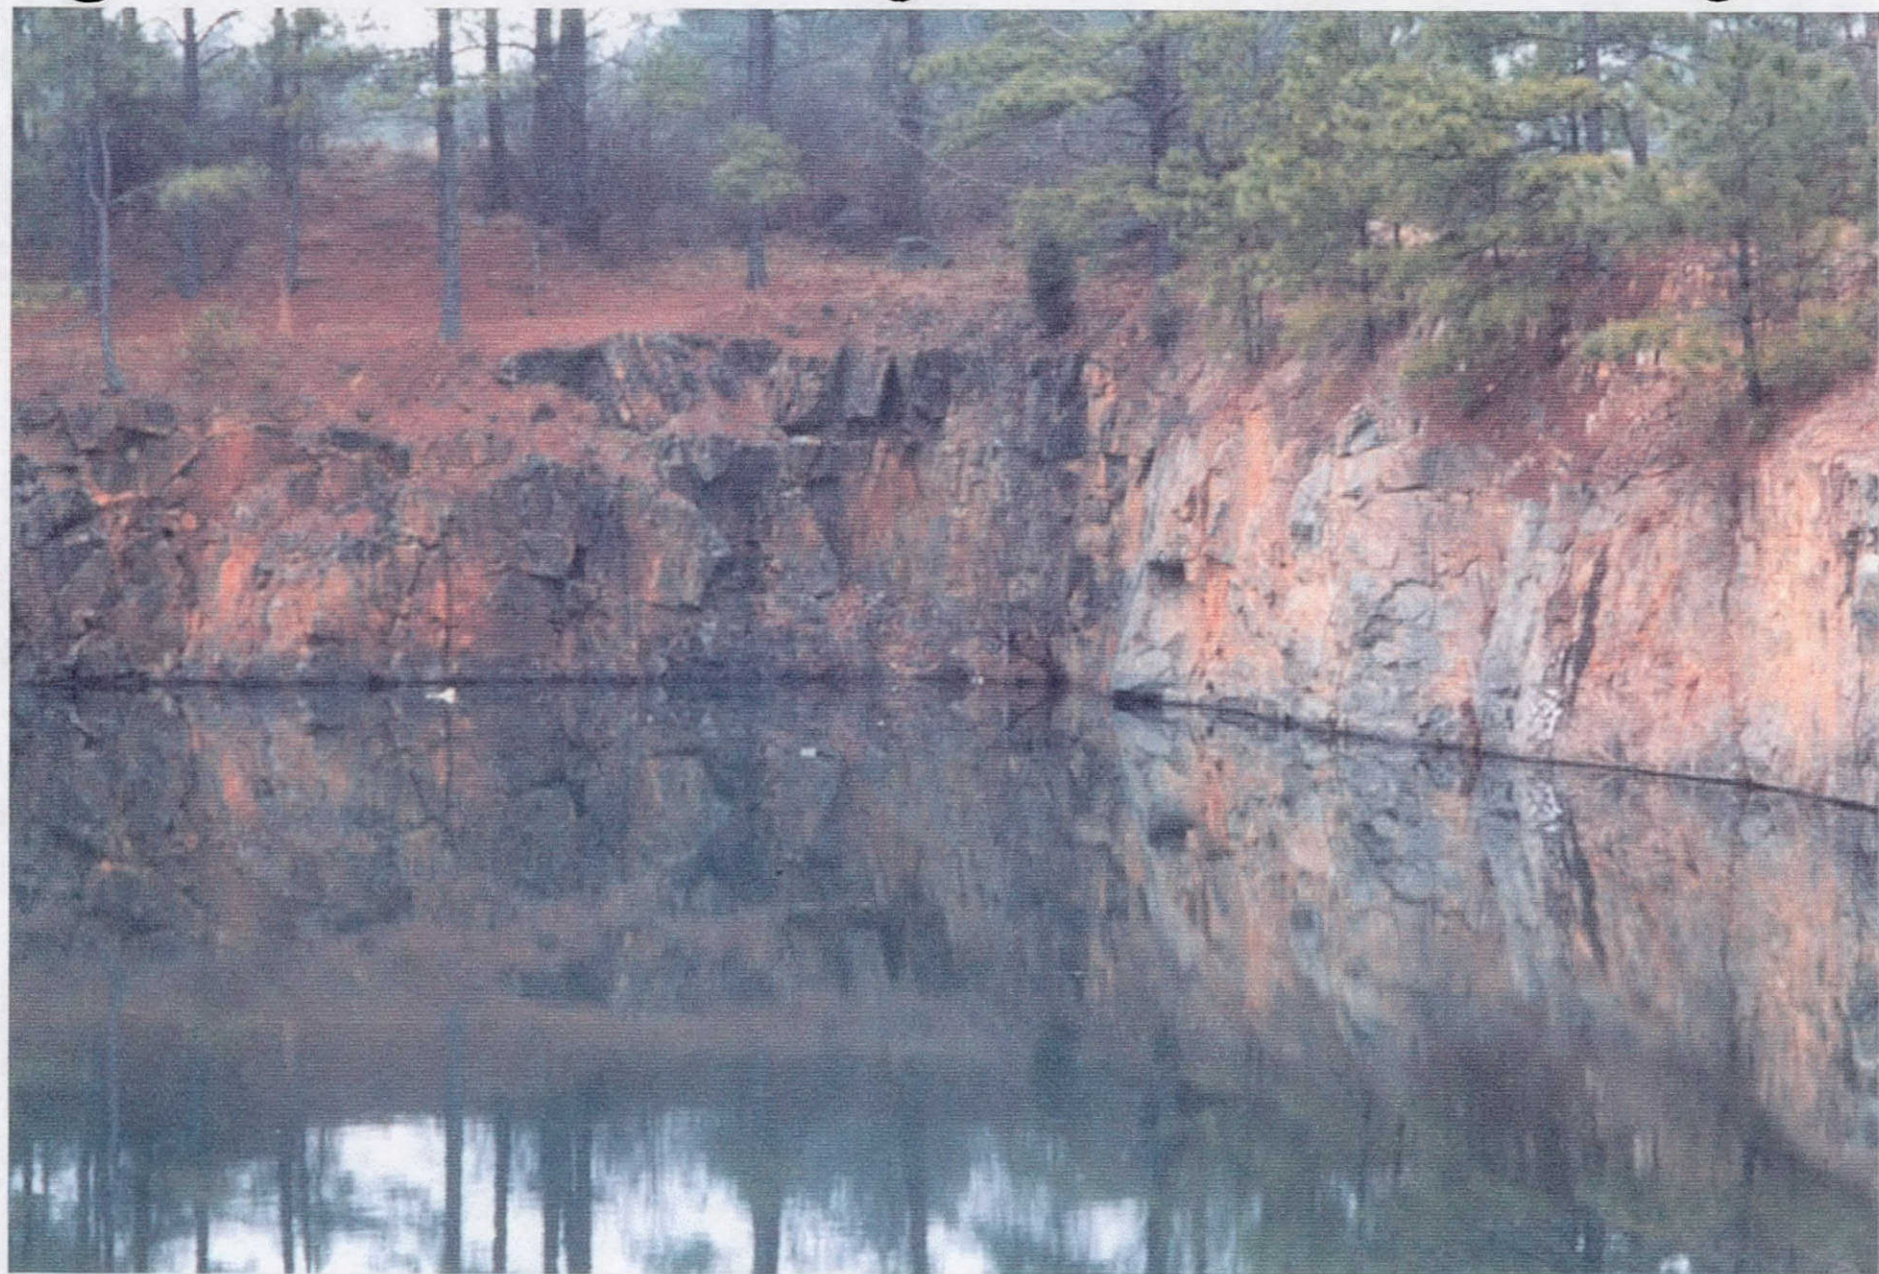
Fig No. 2-3

Figure 2-3 shows the northwest corner of the quarry. Several east-west vertical fractures are visible along with a nearly horizontal fracture located approximately 1/3 of the way from the ground surface to the water surface. The horizontal fracture appears to wrap around to the north face of the quarry.

BEDROCK FRACTURES
(NORTHWESTERN QUARRY WALL)
NCDOT SITE NO. 6-48
