Re: Laurel Ridge 1B and 2B Final Plat and Application

Violations and persistent issues with sediment and erosion control

Laurel Ridge 1B - this is the part of the development located on the south side of Dry Creek, and opposite properties in the Rock Rest neighborhood.

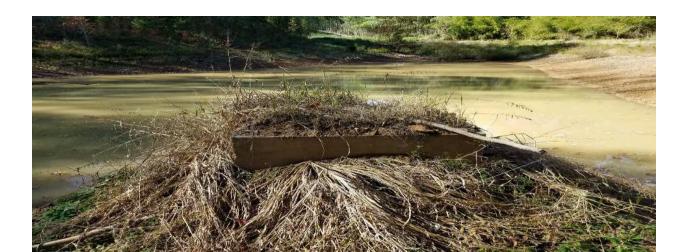
10/28/19 Corrective actions include removing slope drains, removing debris from top of sediment basin riser (see photo below), and removing mud from street at construction entrance.

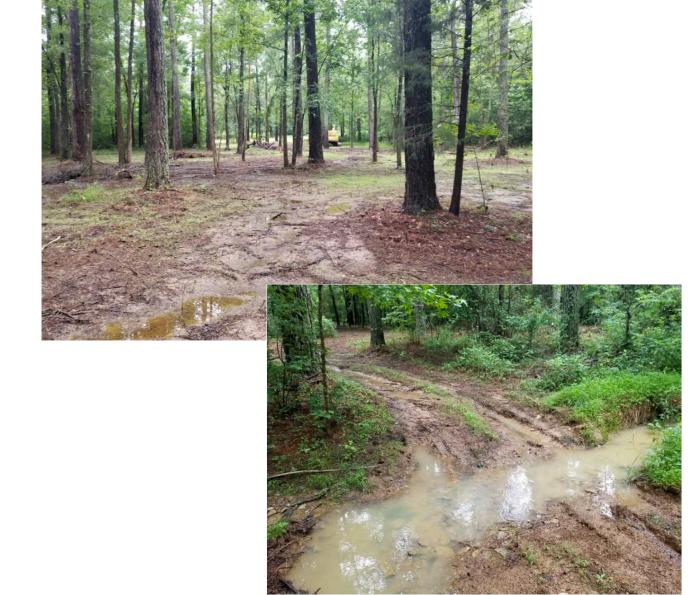
6/17/20 At this initial inspection, the site was found not in compliance with the ordinance and SPCA rules. There was no approved plan, inadequate riparian buffer zone, and clearing outside the limits of the disturbance area, with impacts to the buffer zone (see photos below).

6/19 20 Notice of Violation issued with all corrections to be in place by July 3, including submitting Land Disturbance permit application and S &E plan and stream buffer restoration plan. All lands outside of disturbance limit must be stabilized and seeded with native plant seed in buffer zone.

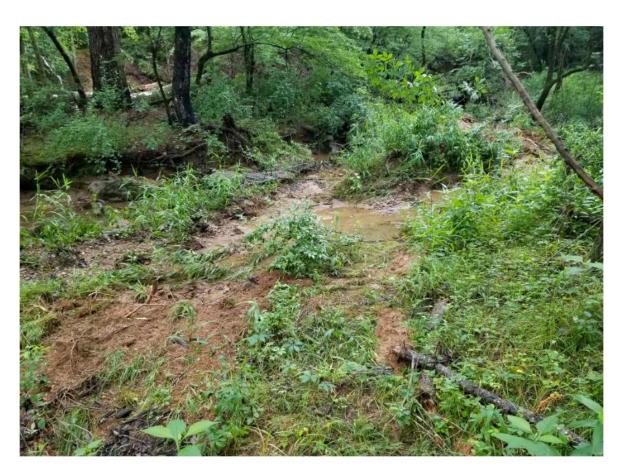
5/20/20 Site is not in compliance with ordinance and rules. Land disturbance activities have occurred in 2 parcels (86857 and 86859 without permit of erosion control plan. (Note: This is the property next to Daniel Amero, where land disturbance and tree cutting occurred on his adjacent property, along the boundary line from Rock Rest Road all the way to Dry Creek, creating a unauthorized access road)

Photo shows land disturbance in Dry Creek riparian buffer zone.

5/21/20 Notice of Violation Issued for problems cited on 5/20/20. Corrections required by June 5, 2020 and no project activity until site is in compliance. After June 5, if not corrected, fines of up to \$5000 a day can be assessed by the county (from 5/21). **6/19/20 The Land Disturbance permit for Phase 3 was revoked.** All problems must be fixed before applicant can reapply for new permit.

- 3. The developer should be required to compensate Daniel Amero, without conditions, for the replacement value of the trees that were illegally cut. The unauthorized road should be closed off so that it can no longer be accessed from either Rock Rest Road or internally, along the property line.

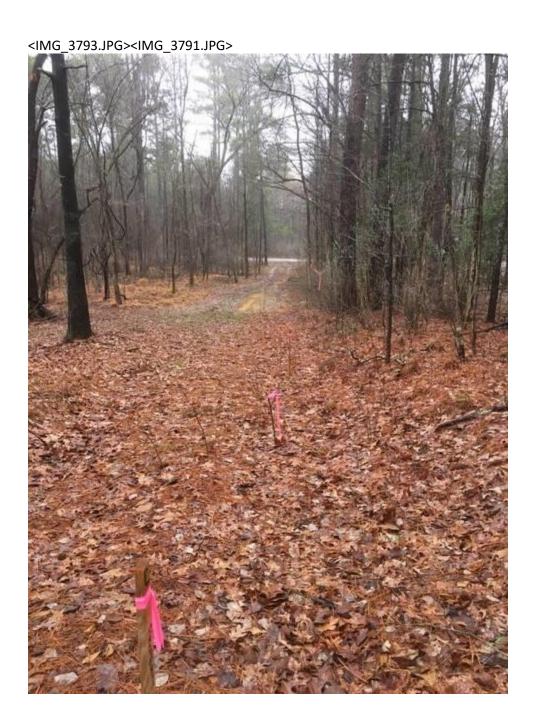
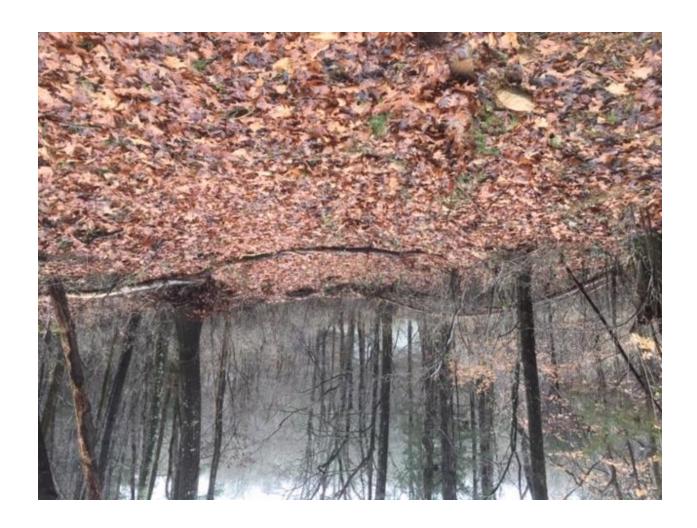
I want to address one issue which is the "road" made north to south on and over the eastern line of lots 46, 45, and 35R and the property of Daniel Amero and Laura Wall. The smaller former firelane was widened by a bulldozer in June of 2020. Two open spaces were made that look like potential housesites. This widened section that has since been driven on by numerous vehicles was not covered with hay and grass seed and is eroding especially on the southernmost hillside that empties into the creek.

One idea I have is to plant hollies, cedars, or other native trees found in this area and place the piled up debris now in the open areas of 46 and 45 to act as mulch and protect the plantings from being run over by vehicles. This would also reduce the piles in their current placement. I am sending two photos taken the last week of December 2020. One is looking north toward Rock Rest Road showing vehicle tracks and the property line stakes showing clearing on both sides of the line. The second looks south on the last hill down towards the creek.

What we have heard is that they are willing to plant trees so that it will not be used as a road. No detectable action has been taken.
