WATERSHED PROTECTION DEPARTMENT

Project Name: Savannah Ridge (Parcel 11229)

Location: 1052 Moncure School Road, Chatham County

Subject Features: Three (3) ephemeral segments, two (2) intermittent segments, one (1) perennial segment, eleven (11) wetlands

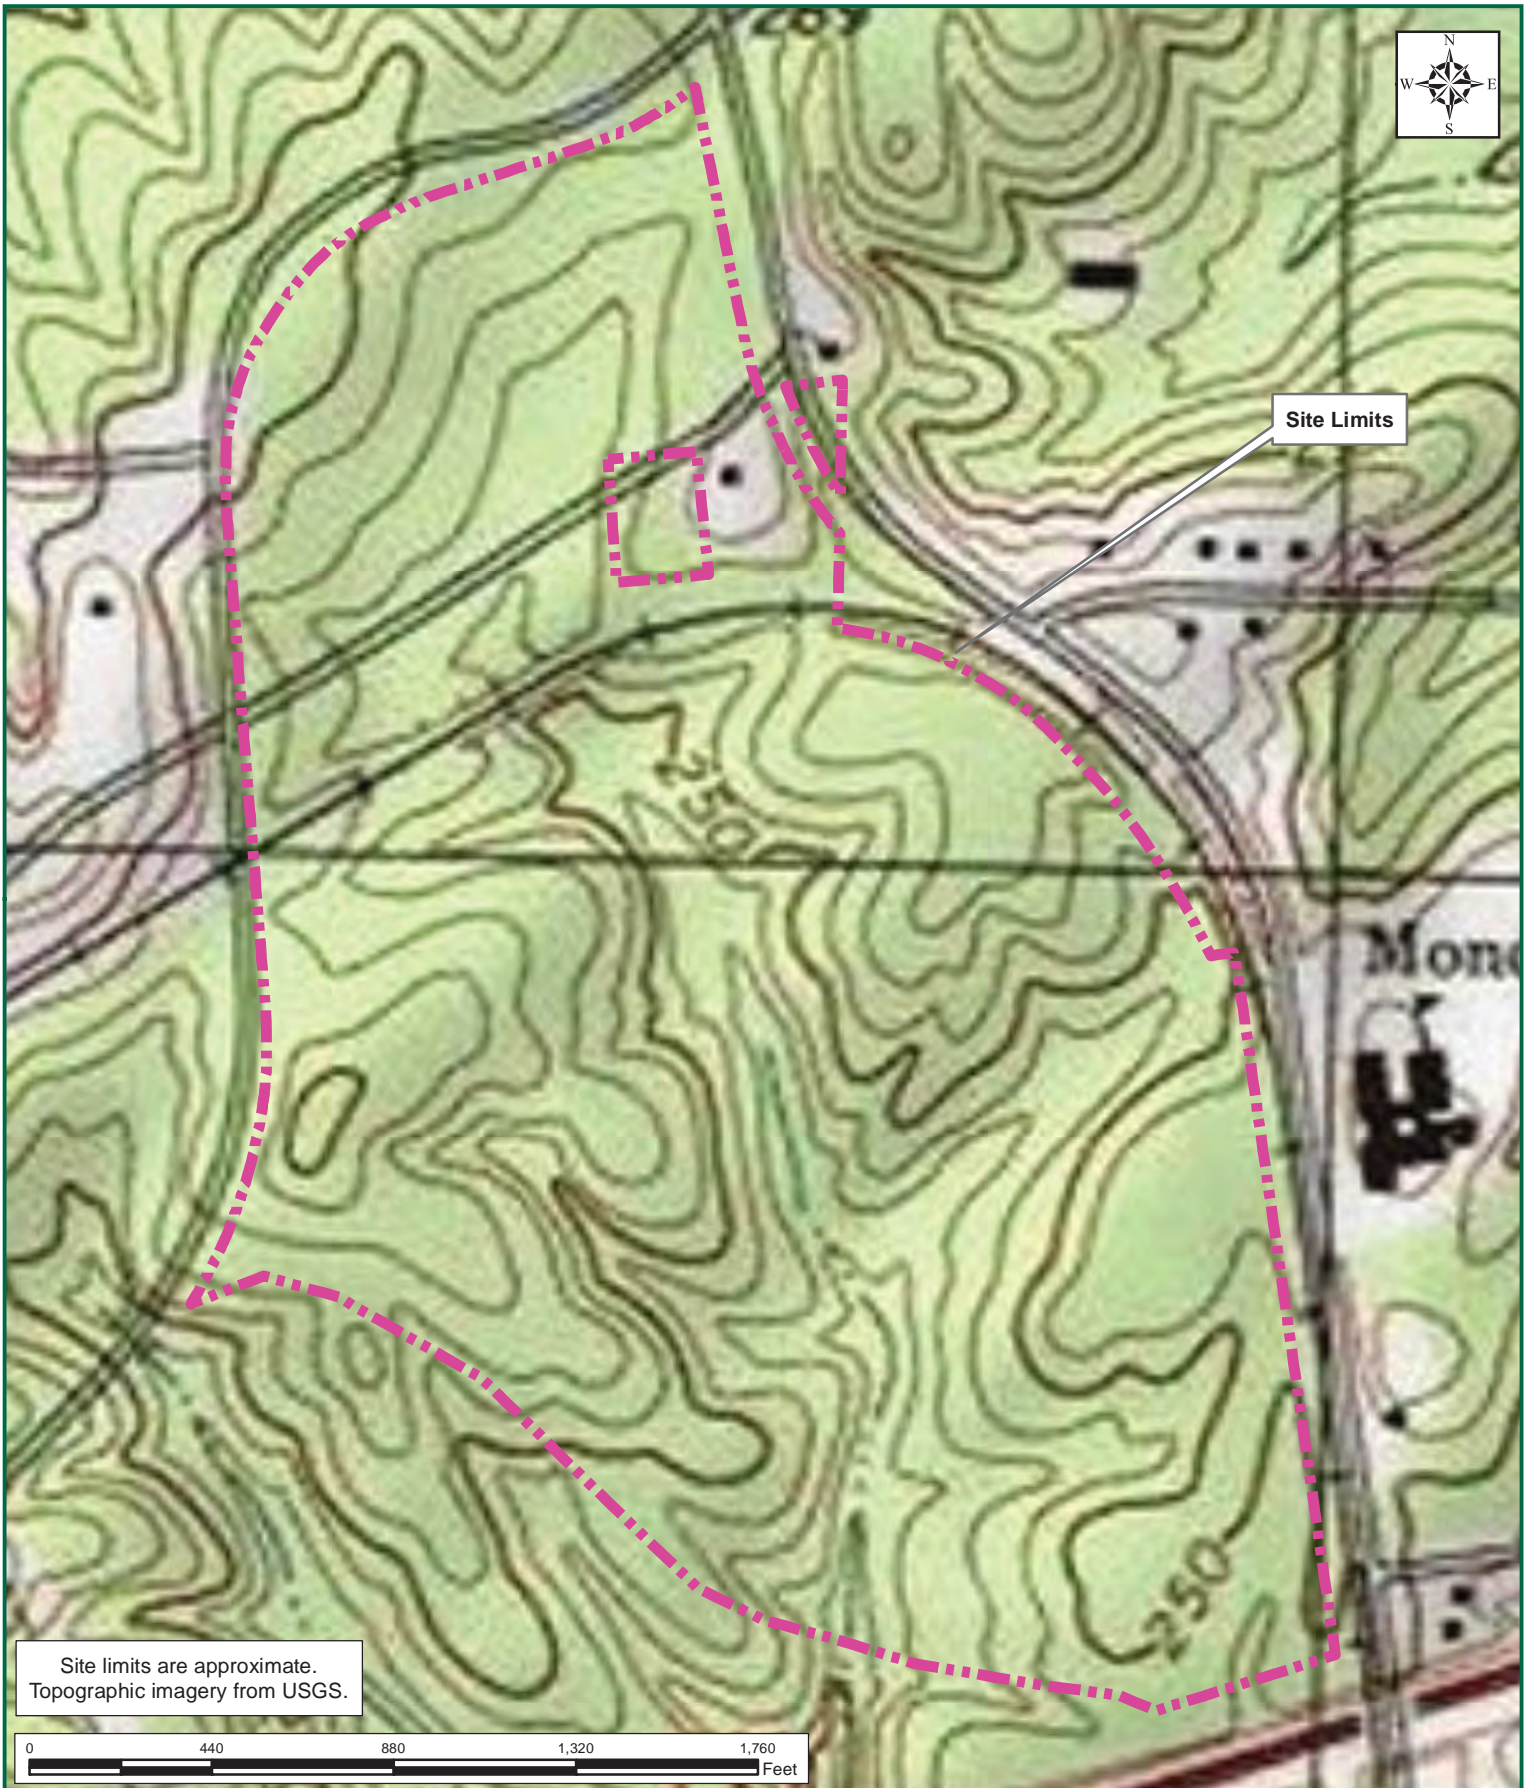
Site limits are approximate.
Topographic imagery from USGS.

- Project Study Limits - 150 Acres
- National Hydrography Dataset
- National Wetlands Inventory
- Zone A: 1% Annual Chance Flood Hazard
