WATERSHED PROTECTION DEPARTMENT

Project Name: Parks at Meadowview, Parcel #'s 10893, 83997, 61935, 5983, 85239, 85043, 5909, 5912, 89724, 89725, 89728, 89727

Re: Wetland Delineation and Stream Evaluation
Parks at Meadowview Property
Chatham County, NC

**CHATHAM COUNTY BUFFER EVALUATION
FOR THE PARKS AT MEADOWVIEW PROPERTY**

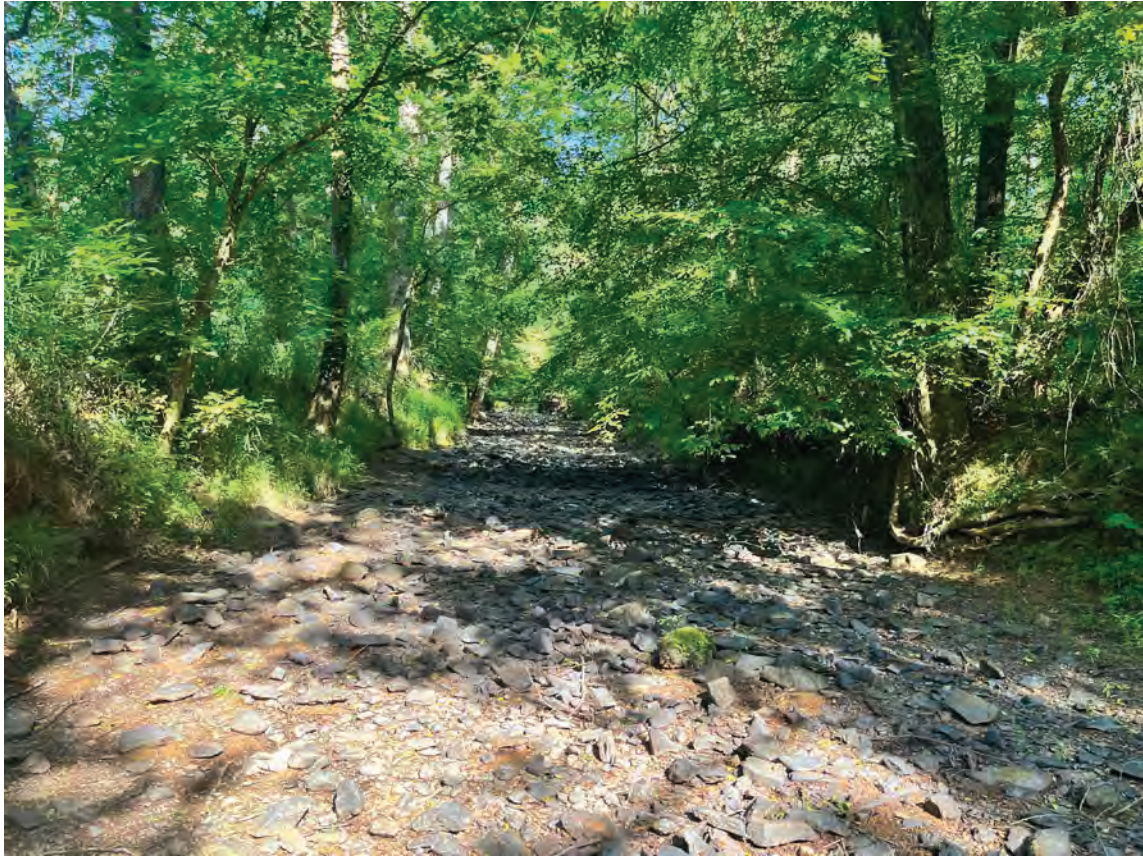
Photo 1: Feature A

- Feature A (Dry Creek) is a wide perennial channel along the northern property boundary.
- Feature B (UT to Dry Creek) starts at flag S01 and will likely be considered perennial until its convergence with Feature A.

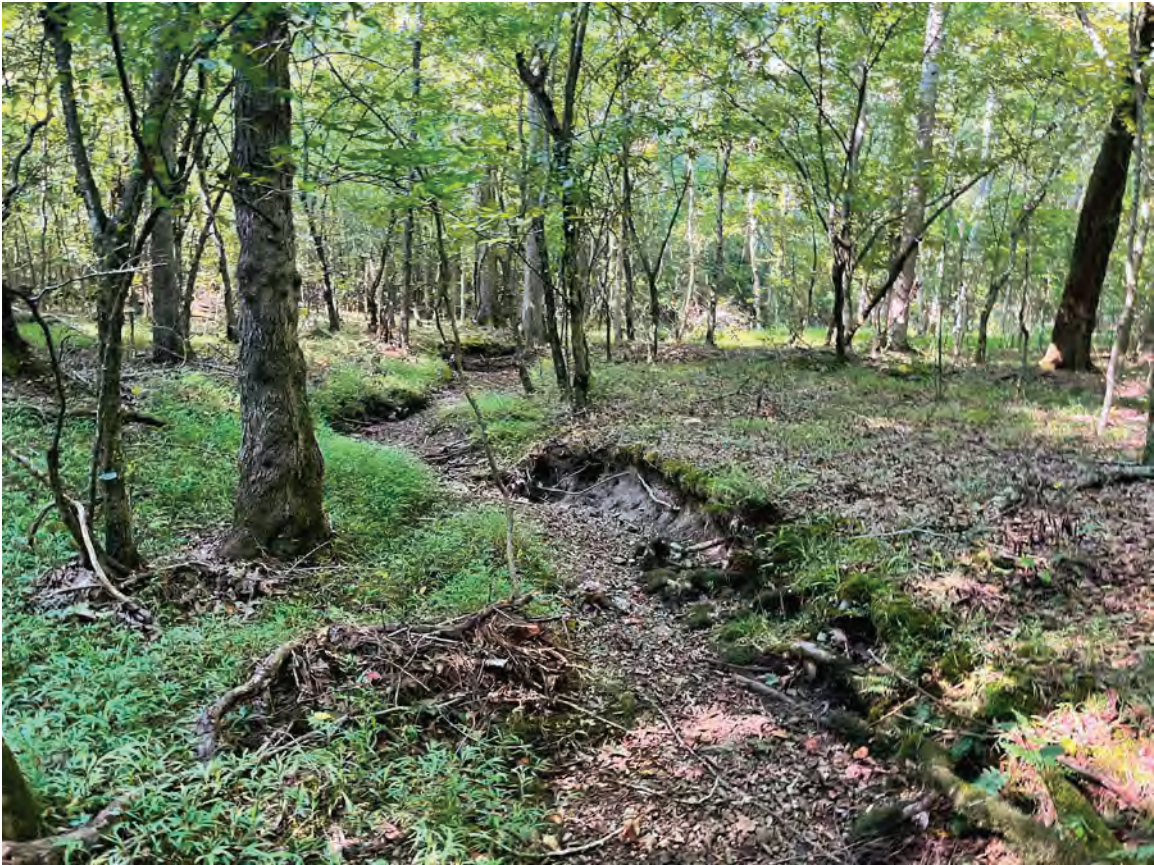
Photo 3: Feature B (Intermittent)

- Feature B (UT to Dry Creek) starts at flag JHS03 and is believed to be intermittent until dissipating into wetland W25. This feature starts again at flag JHS02 and is believed to be intermittent until flag S01.

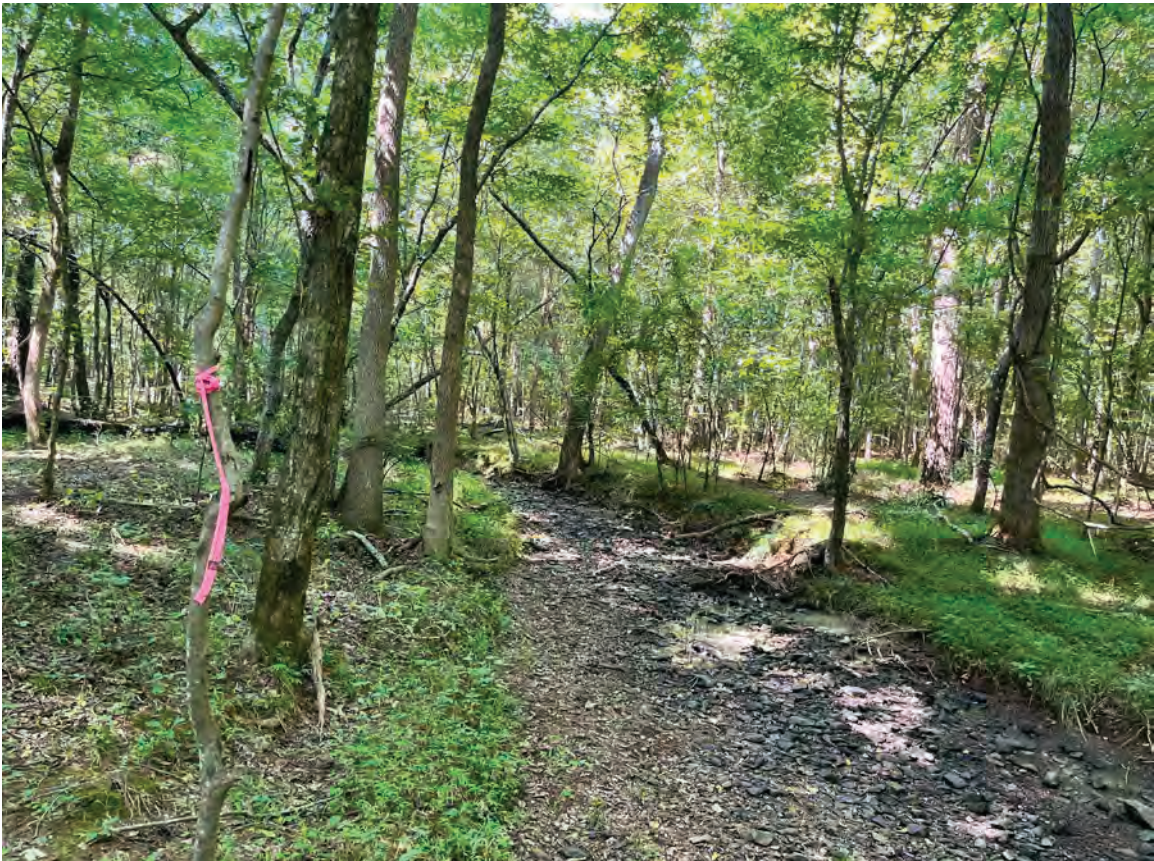
Photo 4: Feature C

- Feature C (UT to Brooks Creek) starts off property to the north and is likely perennial until its convergence with Feature E.
- Feature C2 (UT to Brooks Creek) starts off property to the north and is likely perennial until its convergence with Feature C2.

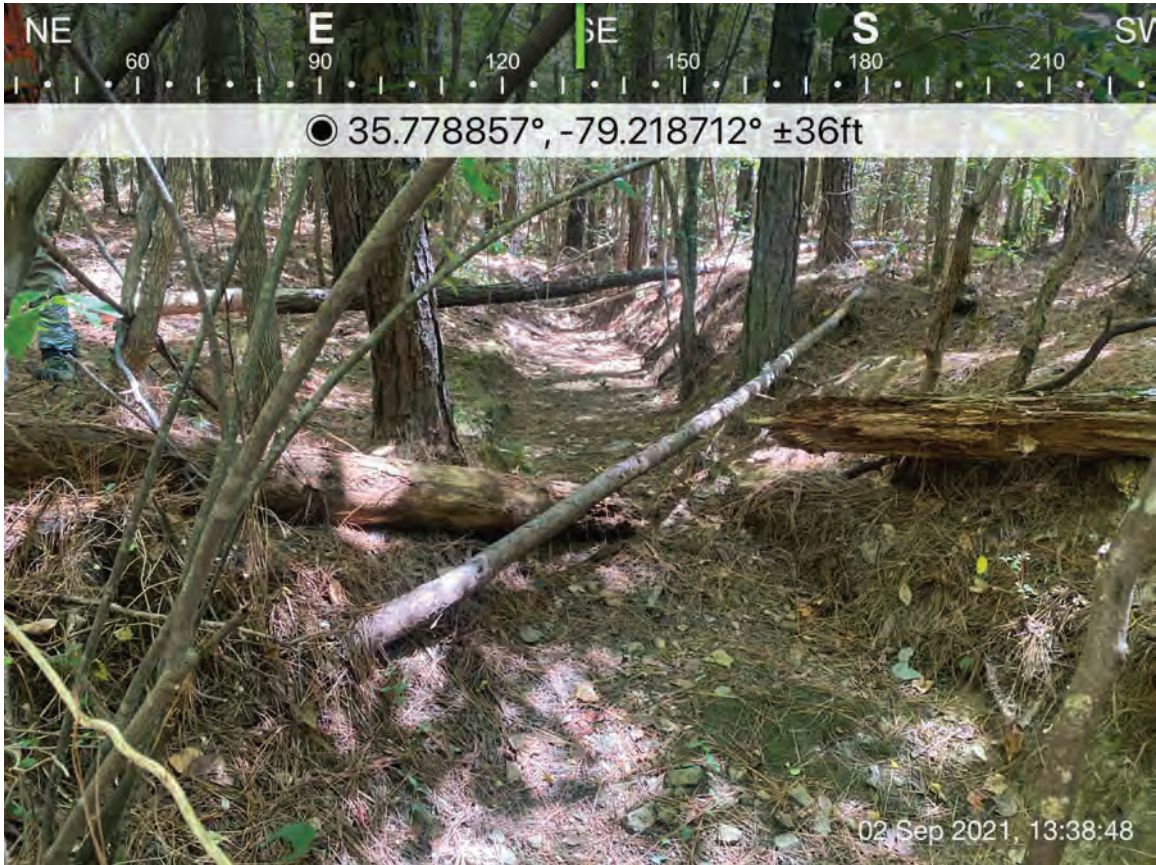
Photo 5: Feature D

- Feature B2 (UT to Dry Creek) starts of flag JHS01 and is believed to be intermittent until its convergence with Feature B.
- Feature D (UT to Brooks Creek) starts at flag S04 and will likely be considered intermittent until dissipating into a wetland at flag S05.

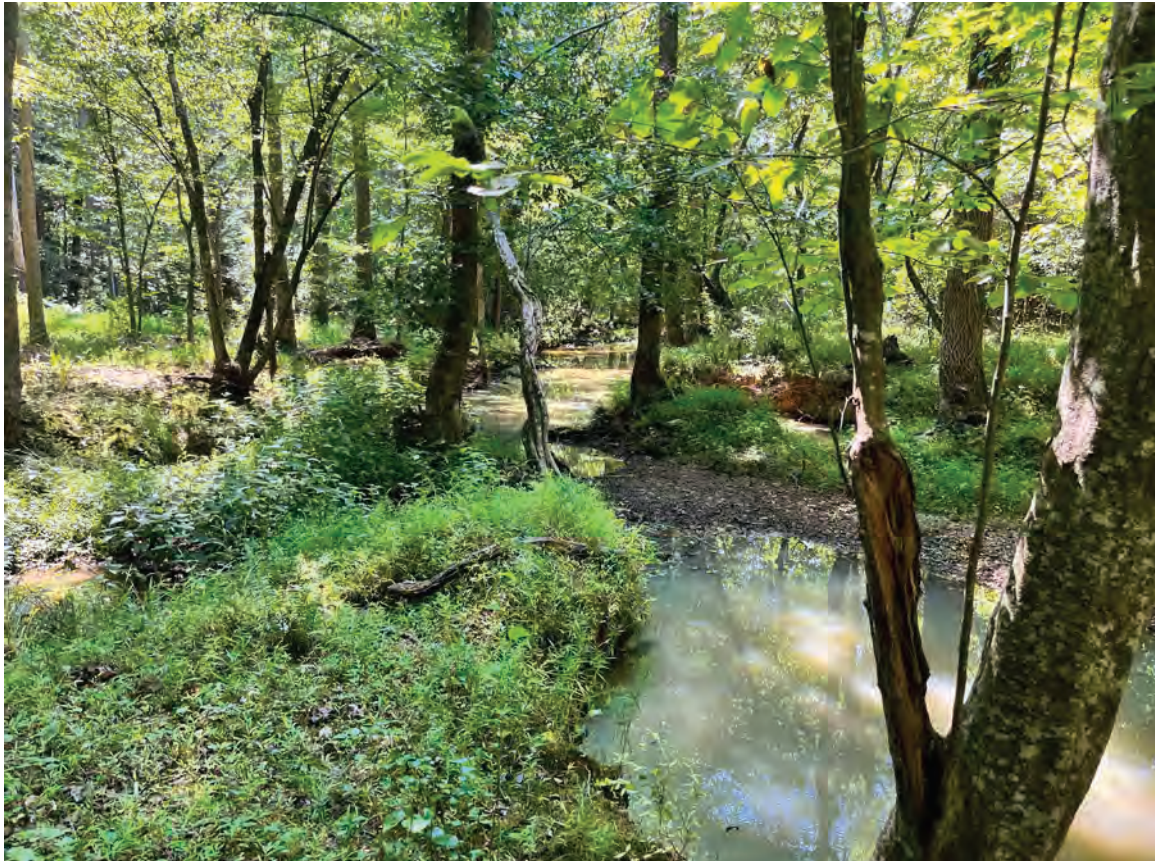
Photo 6: Feature E

- Feature E (UT to Brooks Creek) starts off property to the west and is believed to be perennial throughout its extent.
- Feature G (UT to Brooks Creek) starts off property to the north and will likely be considered perennial until its convergence with Feature E.

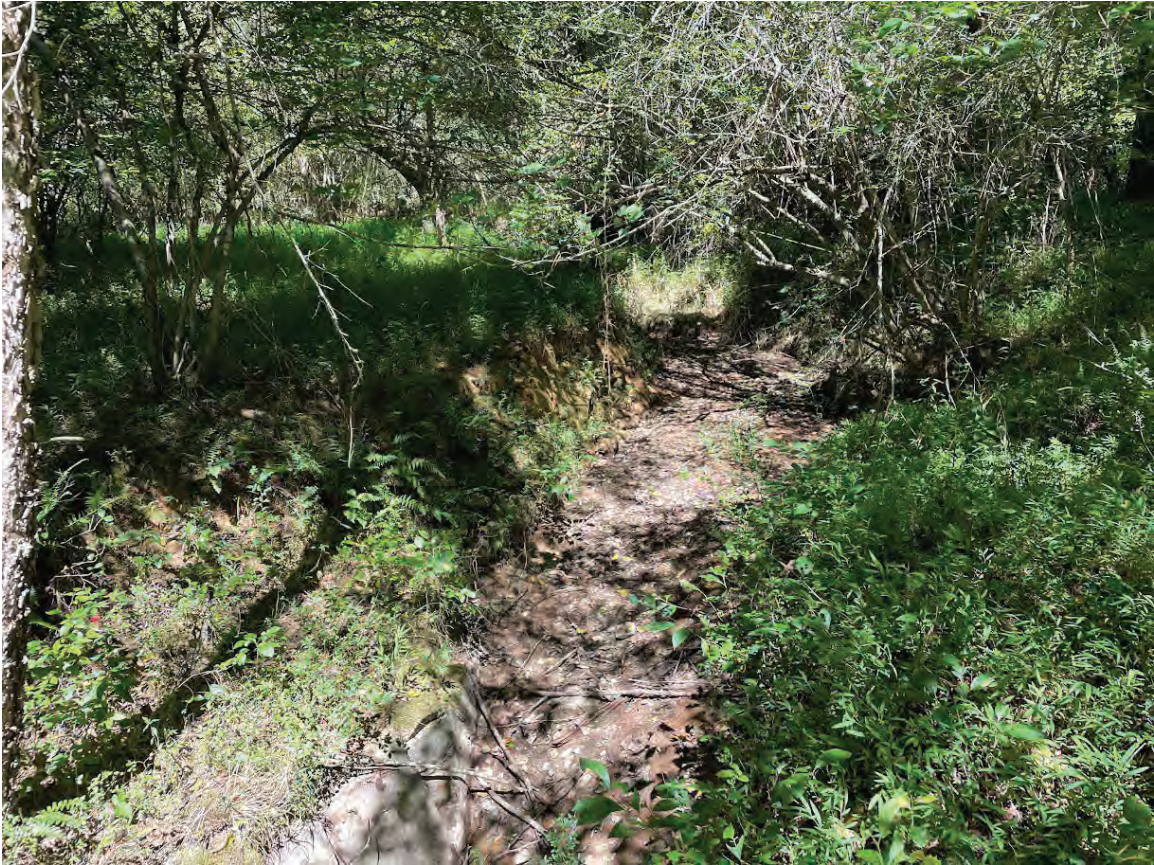
Photo 7: Feature F

- Feature F (UT to Brooks Creek) starts off property to the south as will likely be considered perennial until its convergence with Feature E.

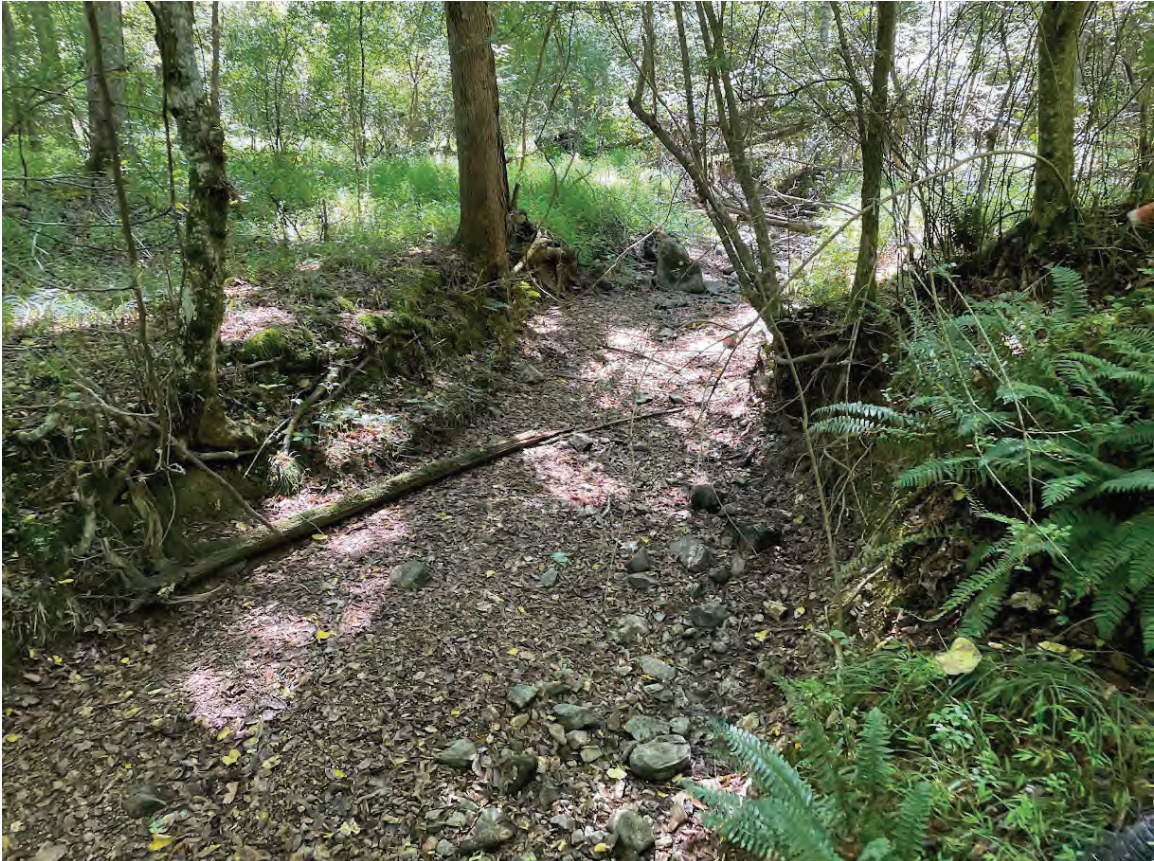
Photo 8: Feature G

- Feature G (UT to Brooks Creek) starts off property to the north and is believed to be intermittent throughout its extent.
- Feature M (UT to Brooks Creek) starts at flag JHS04 and is believed to be intermittent until its convergence with Feature C.

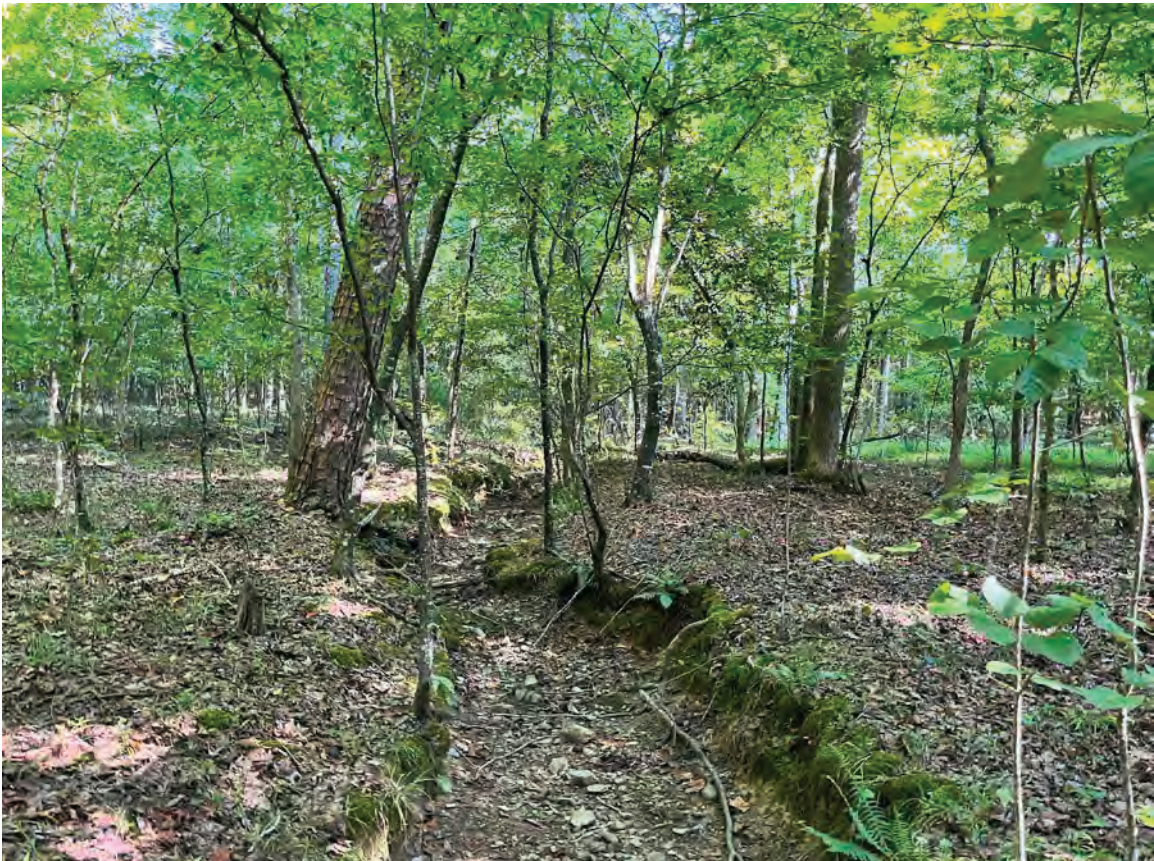
Photo 10: Feature K

- Feature K (UT to Dry Creek) starts at flag S02 and is believed to be intermittent until its convergence with Feature B.
- Feature Z (UT to Brooks Creek) starts at flag S03 and is believed to be intermittent until its convergence with Feature C.

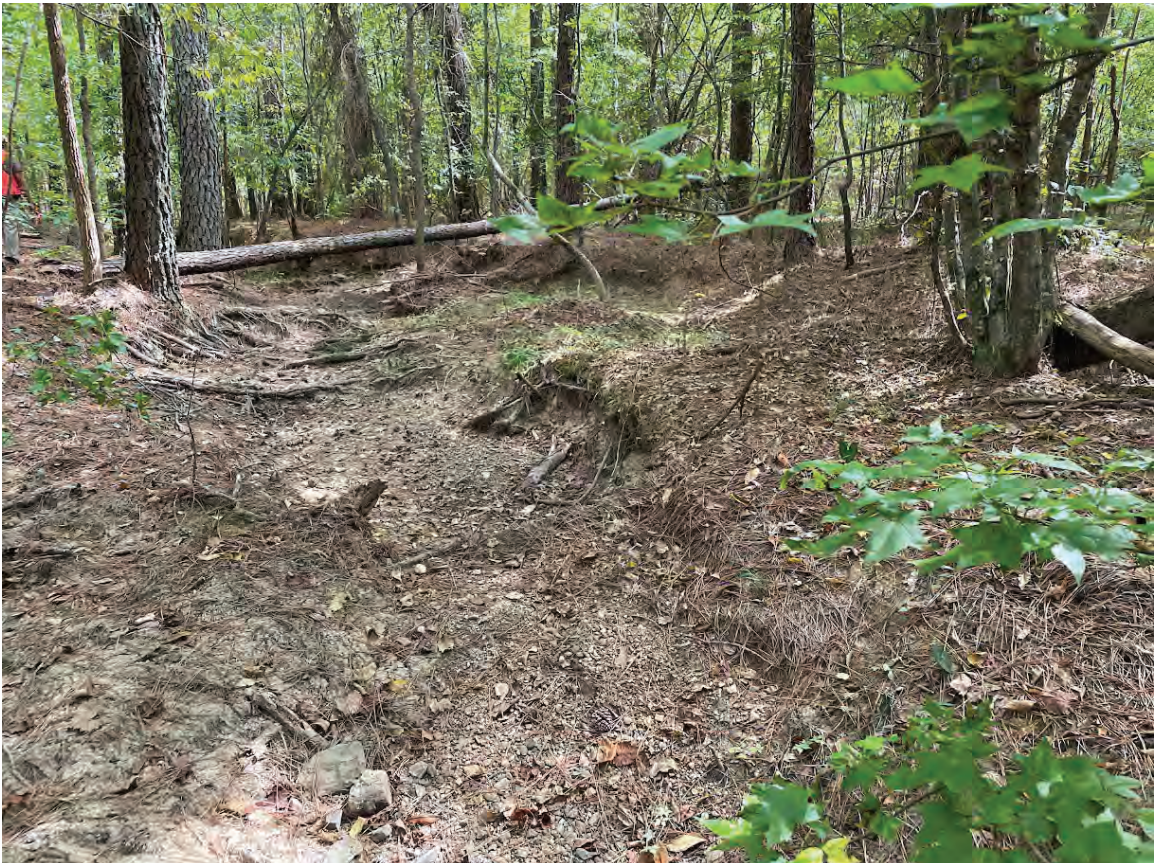
Photo 12: Feature E1

- Feature E1 (UT to Dry Creek) starts at flag KM E01 and is believed to be ephemeral until its convergence with Feature B.
- Feature E2 (UT to Dry Creek) starts at flag E01 and is believed to be ephemeral until flag E02.
- Feature E3 (UT to Dry Creek) starts at flag E03 and is believed to be ephemeral until flag E04.
- Feature E4 (UT to Dry Creek) starts at flag E05 and is believed to be ephemeral until flag E06.
- Feature E5 (UT to Brooks Creek) starts at flag E07 and is believed to be ephemeral throughout its extent.

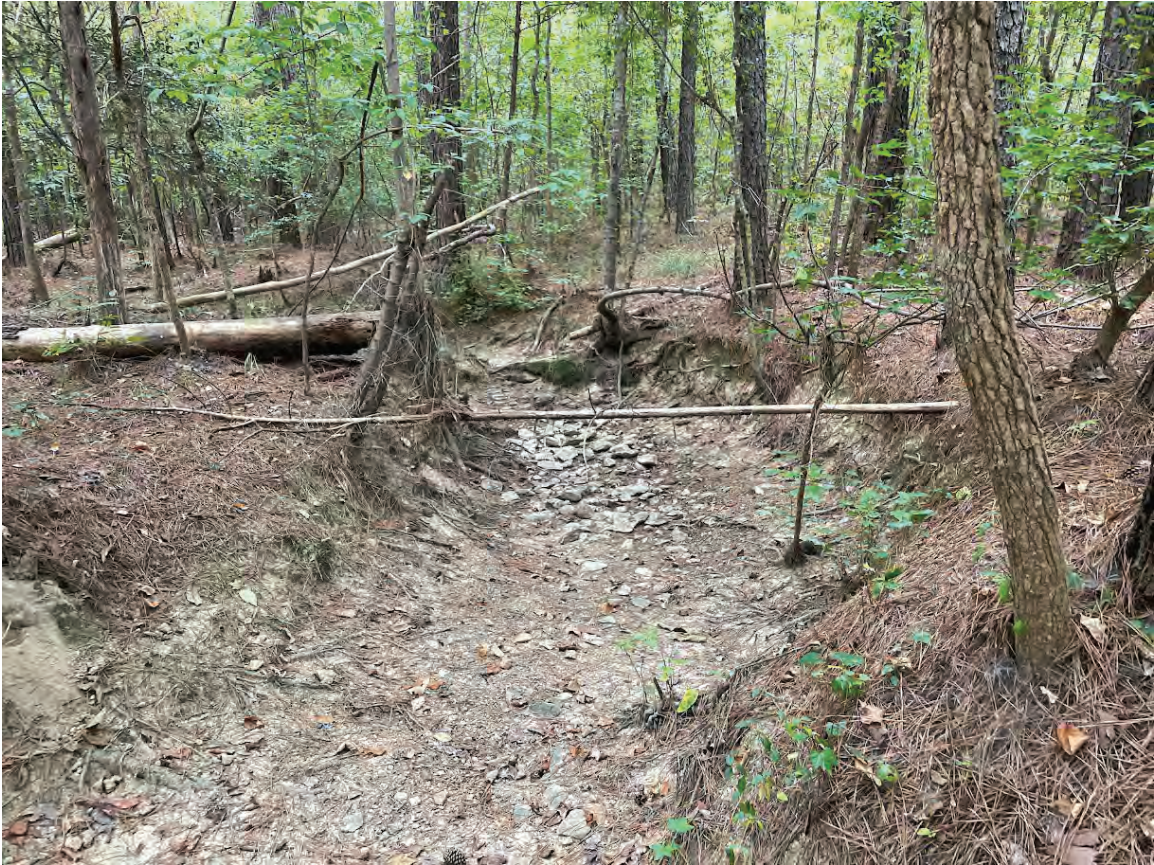
Photo 17: Feature E7

- Feature E6 (UT to Brooks Creek) starts at flag E08 and is believed to be ephemeral until its convergence with Feature E5.
- Feature E7 (UT to Brooks Creek) starts at flag E12 and is believed to be ephemeral until flag JHS04.
- Feature E8 (UT to Brooks Creek) starts at flag KM E03 and is believed to be ephemeral until flag S04.
- Feature E9 (UT to Brooks Creek) starts at flag KM E02 and is believed to be ephemeral until flag E04.
- Feature E10 (UT to Brooks Creek) starts at flag E10 and is believed to be ephemeral until its convergence with Feature G.
- Feature E11 (UT to Brooks Creek) starts at flag E11 and is believed to be ephemeral until its convergence with Feature E.
- Feature E12 (UT to Brooks Creek) starts at flag E09 and is believed to be ephemeral until flag LW15.
