Groundwater Management Associates, Inc. 2205-A Candun Drive Apex, NC 27523 Telephone 919-363-6310 www.gma-nc.com

Re: Hydrogeologic Evaluation Report, Pyewacket Subdivision, Chatham County, NC

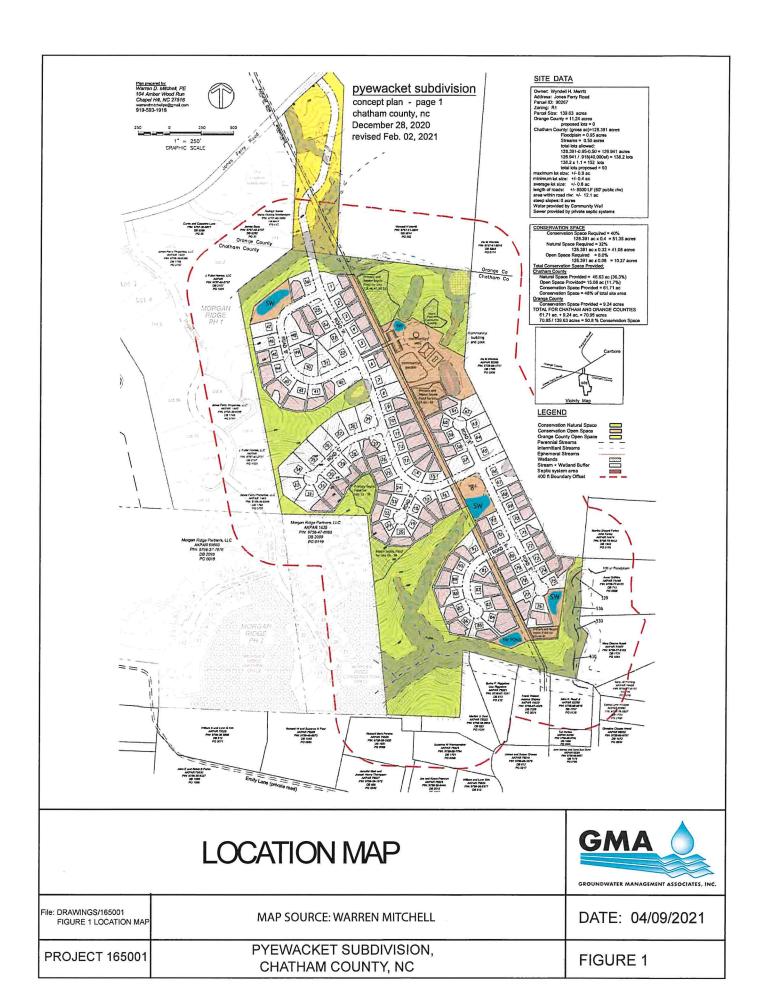
Groundwater Management Associates, Inc. (GMA) completed a hydrogeological evaluation of the Pyewacket Subdivision property in Chatham County, NC (Figure 1). Using existing mapping by others that you provided to us, and a geophysical survey of the area conducted by Geo-Solutions, Ltd., GMA selected two potential water-supply well site areas that will hopefully fulfill your needs for this development. Based on our investigation, we believe these two areas have the potential to provide the highest well yields of accessible locations on the site. Both sites are associated with interpreted fracture trends, as described below, and both locations are indicated on the attached map.

There are two stream valleys of primary interest on the Pyewacket Subdivision. GMA identified a potential well site labelled A (Figure 2). That well location is close to a well location you included in your concept plan (Figure 1) along the ridge line. However, we prefer to place the well southwest of the road and farther down the stream valley to a location near the confluence of that stream with another. While the original location you choose may provide an adequate well, GMA believes this new location is better suited to tap into a possible larger fracture system. A connection to a larger fracture system may be important to the success of this well due to the general limited water-storage capabilities associated with the thin saprolite in this area where the granodiorite pluton has been mapped by NCGS.
