Environmental Impact Assessment

To: Western Intake Partnership

From: CDM Smith

Subject: Environmental Impact Assessment

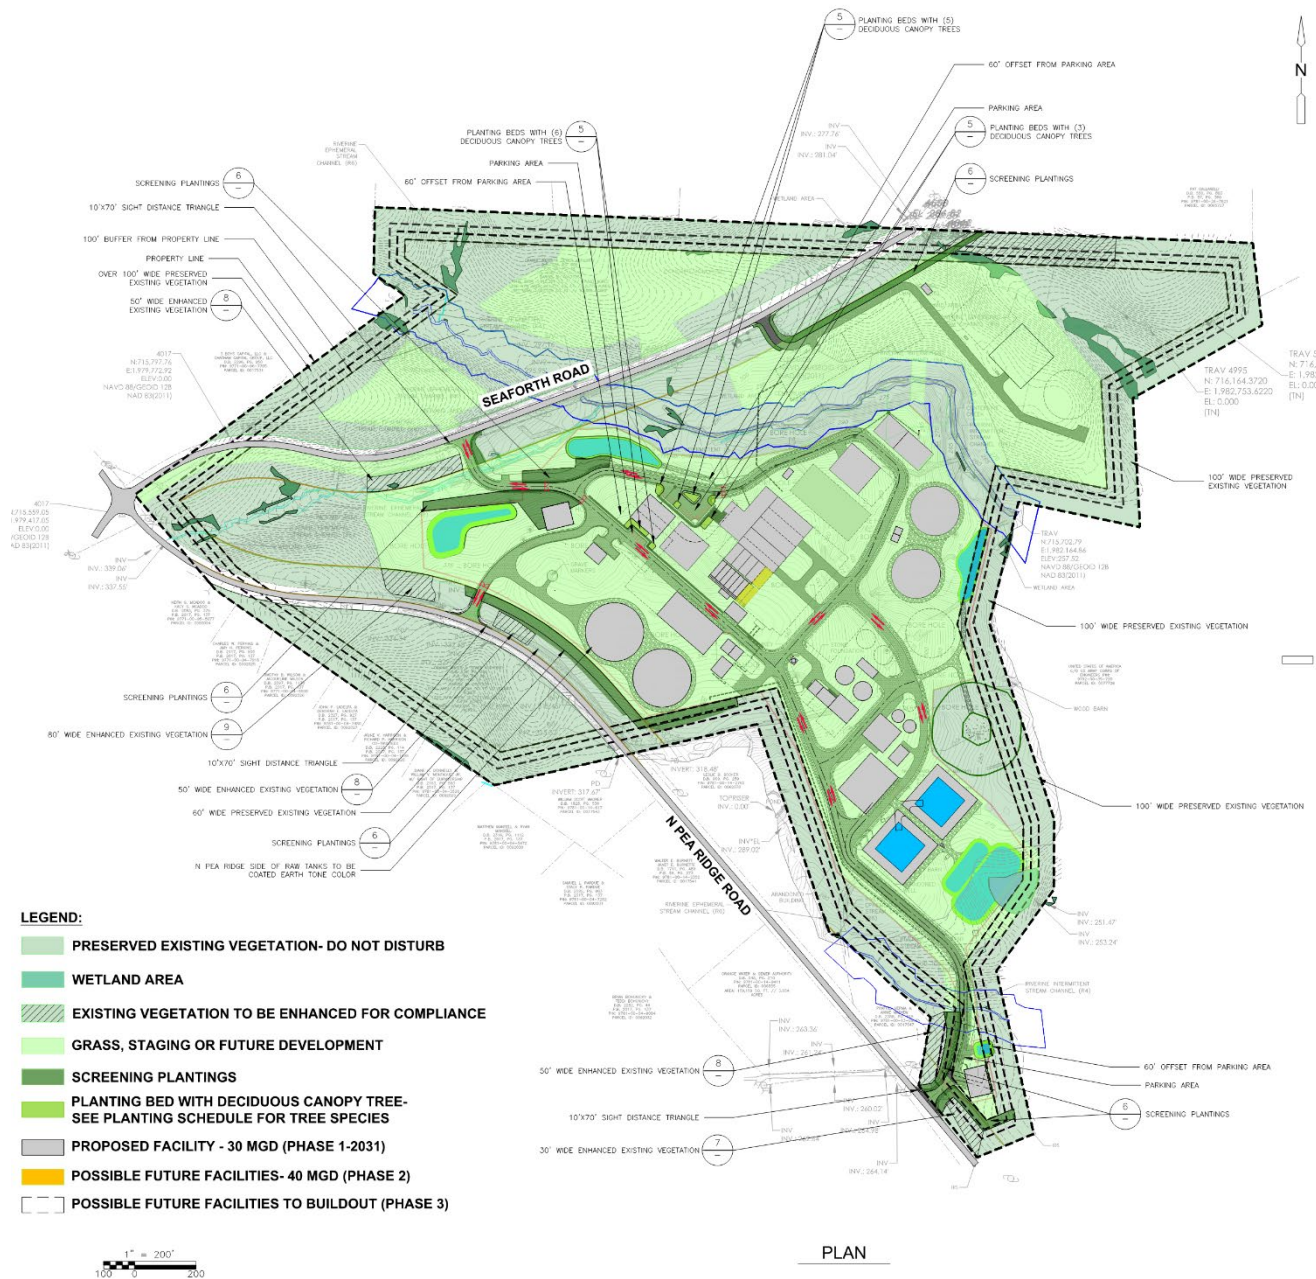
Figure 7 | Preliminary Site Landscape Plan

As shown in **Figure 7**, there are areas to be cleared, paved, and landscaped throughout the project area. Areas that are anticipated to be cleared will be where buildings and facilities (shaded in light gray), possible future facilities (shaded in orange), and paved roads, parking lots, and walkways (shaded in dark gray) will be located. All paved areas will be on the property south of Seaforth Road and will be utilized to connect the WTF entrances and exits with Seaforth Road and North Pea Ridge Road, in addition to connecting buildings and facilities with one another. However, there will be landscaping both south and north of Seaforth Road, as can be seen on the preliminary site landscape plan (Figure 7). Long term (over 40 years) and other possible, but uncertain spaces are marked with black dash outlines on Figure 7. To the north of Seaforth Road, segments of the land on either side of the 50-foot riparian buffer adjacent to the intermittent stream will be cleared and landscaped with grass for staging or future development, though most of existing vegetation will be preserved and undisturbed. There are also wetlands on either side of the intermittent stream in the northeast and wetlands directly to the north of Seaforth Road that will remain untouched. To the south of Seaforth Road and to the north of North Pea Ridge Road, there will be a 50-to-100-foot buffer around the entirety of the RWTF that will be composed of the preserved and undisturbed existing vegetation. Images of the existing vegetation on the edge of the site as if looking from Seaforth Road can be seen in the right 3 photos on **Figure 8** with images as if looking from North Pea Ridge Road for the left side 3 photos. The majority of the landscaping on the RWTF property will include grass used for staging or future development, except for the existing vegetated buffer, existing vegetation to be enhanced for compliance, selected areas for screening plantings, and various wetlands (see Figure 7). All land south of North Pea Ridge Road will be preserved and

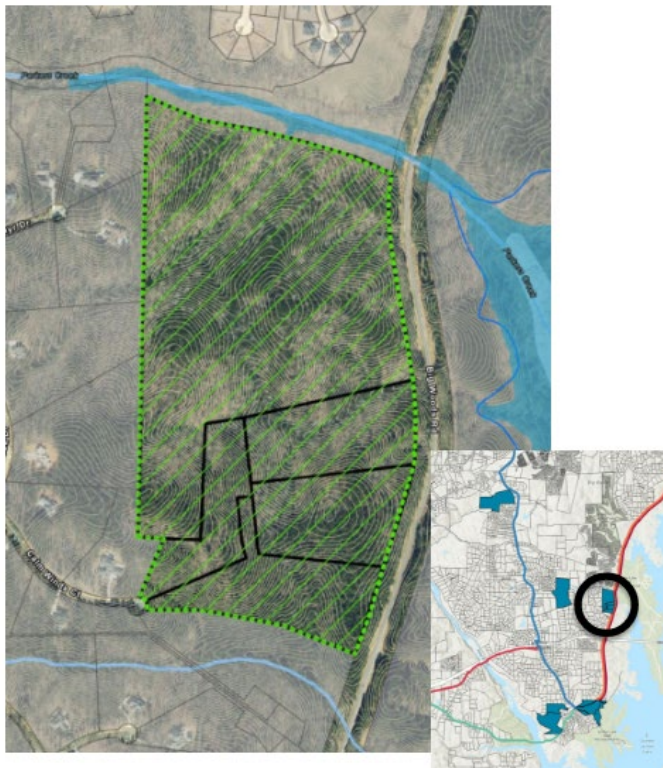
Figure 11 | Alternative 3 RWTF Location

Alternative 3 is to locate the RWTF on land closer to US 64. This site is adjacent to Big Wood Road, north of US 64, and is not centrally located to permit drinking water transmission to Partners without additional transmission mains when compared to Alternative 1. However, it does have adequate size and shape to accommodate the proposed and future water treatment facilities. This property is managed by four owners: F-L Legacy Owner, LLC, Kimberly Ann Kitchens, Ann B. Burke, and Betsy B. Sturdivant. This land has a total area of 88 acres, all of which is buildable. This site is made up of five parcels and both it and the adjacent land are zoned residentially (though required setbacks and buffers can be maintained). Desktop data suggests there are no streams or wetlands on the site. However, the site is too far from the intake location to allow the raw water pump station to be located on the site. Therefore, the raw water pump station would have to be constructed on USACE property leased by NC Parks, on Alternative 1, or additional property in the area of Alternative 1 would need to be acquired. Thus, the construction of the raw water pump station with the other treatment facilities on a common site cannot be achieved with this alternative. As with all alternatives, rezoning would be required. Alternative 3 does not achieve the WIP’s security and operational preferences to co-locate the raw water pump station and RWTF on the same site, will require additional land acquisition, is not centrally located requiring additional pipelines, and provides no environmental benefit over Alternative 1 (the preferred alternative). Based on this analysis, Alternative 3 was considered unacceptable.

Alternative 3 is depicted in **Figure 11**.

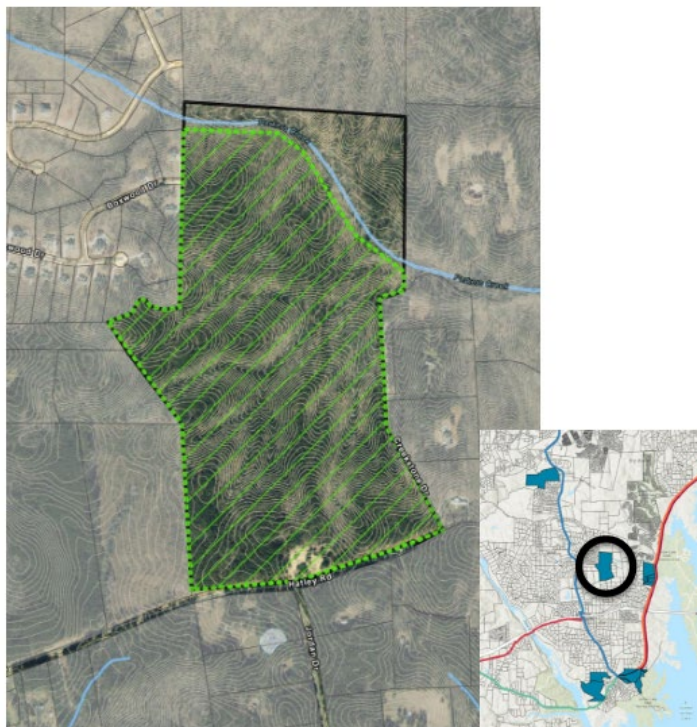
Figure 12 | Alternative 4 RWTF Location

Alternative 4 is to locate the RWTF on a parcel to the west of Alternative 3 and more inland from Jordan Lake, having a single access off Hatley Road. This property is owned by Contentnea Creek Development Company, has a total area of 131 acres, and has a buildable area of 113 acres (the whole parcel except for the land north of Parkers Creek). Alternative 4 has adequate size and shape to accommodate the proposed future water treatment facilities. This site is made up of one parcel and both it and the adjacent land are zoned residentially; the site has conditional zoning for smaller 2-acre lots but is undergoing rezoning to R5, with development planned for the site. The site is north of US 64 and is not centrally located to permit drinking water transmission to the Partners without additional transmission mains compared to Alternative 1. Desktop data suggests there are no streams or wetlands on the site. However, the site is too far from the intake location to allow the raw water pump station to be located on the site. Therefore, the raw water pump station would have to be constructed on USACE property leased by NC Parks, on Alternative 1, or additional property in the area of Alternative 1 would need to be acquired. Thus, the construction of the raw water pump station with the other treatment facilities on a common site cannot be achieved with this alternative. As with all alternatives, rezoning would be required. Alternative 4 does not achieve the WIP's security and operational preferences to co-locate the raw water pump station and RWTF on the same site, will require additional land acquisition, is not centrally located requiring additional pipelines, and provides no environmental benefit over Alternative 1 (the preferred alternative). Based on this analysis, Alternative 4 was considered unacceptable.

Alternative 4 is depicted in **Figure 12**.

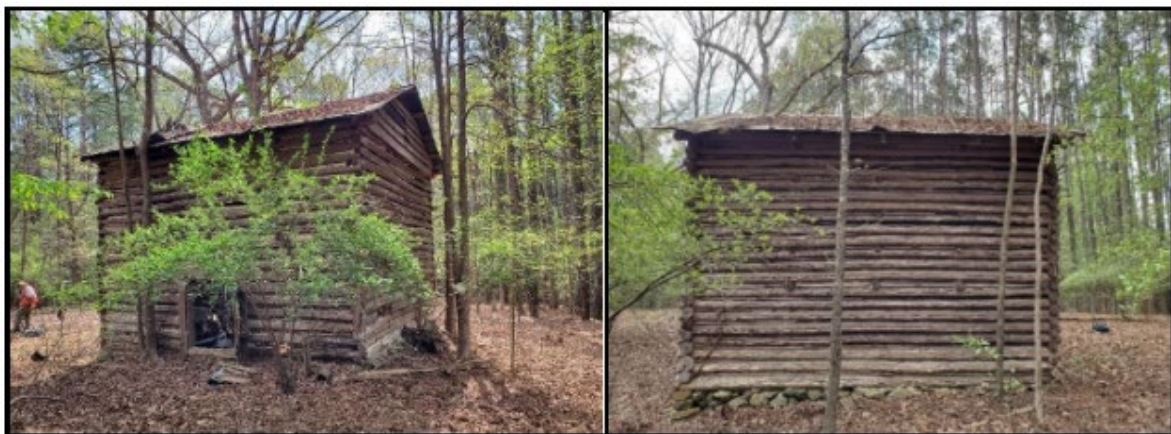
Figure 28 | Barn 1 and Barn 2 at Site 31CH1367

Site 31CH1367 consists of two historic tobacco barns located in the southern-central portion of the RWTF site that likely date to the twentieth century (see **Figure 28**). Both barns are approximately the same size. The northernmost barn, Barn 1, was constructed with logs and concrete chinking. It rests on a stone and concrete foundation and has a sheet metal roof; wire nails were used in its construction. The southernmost barn, Barn 2, is similar in construction, though there are some bricks in the eastern portion of its foundation. Remnants of curing equipment are present, which include pipes, copper tubes, and metal flues used in the process of drying tobacco. No artifacts were recovered, though this is not atypical for sites of this type. While there were no other buildings or features identified in this area, it is likely that these barns are associated with site 31CH1366. One of the barns has been utilized to store modern trash and debris. Due to these factors, this site is unlikely to yield new or significant data to our understanding of historic settlement in this area. It has fulfilled its research potential at this level of the investigation and is recommended not eligible for NRHP (Archaeological Consultants of the Carolinas, Inc. July 2023).

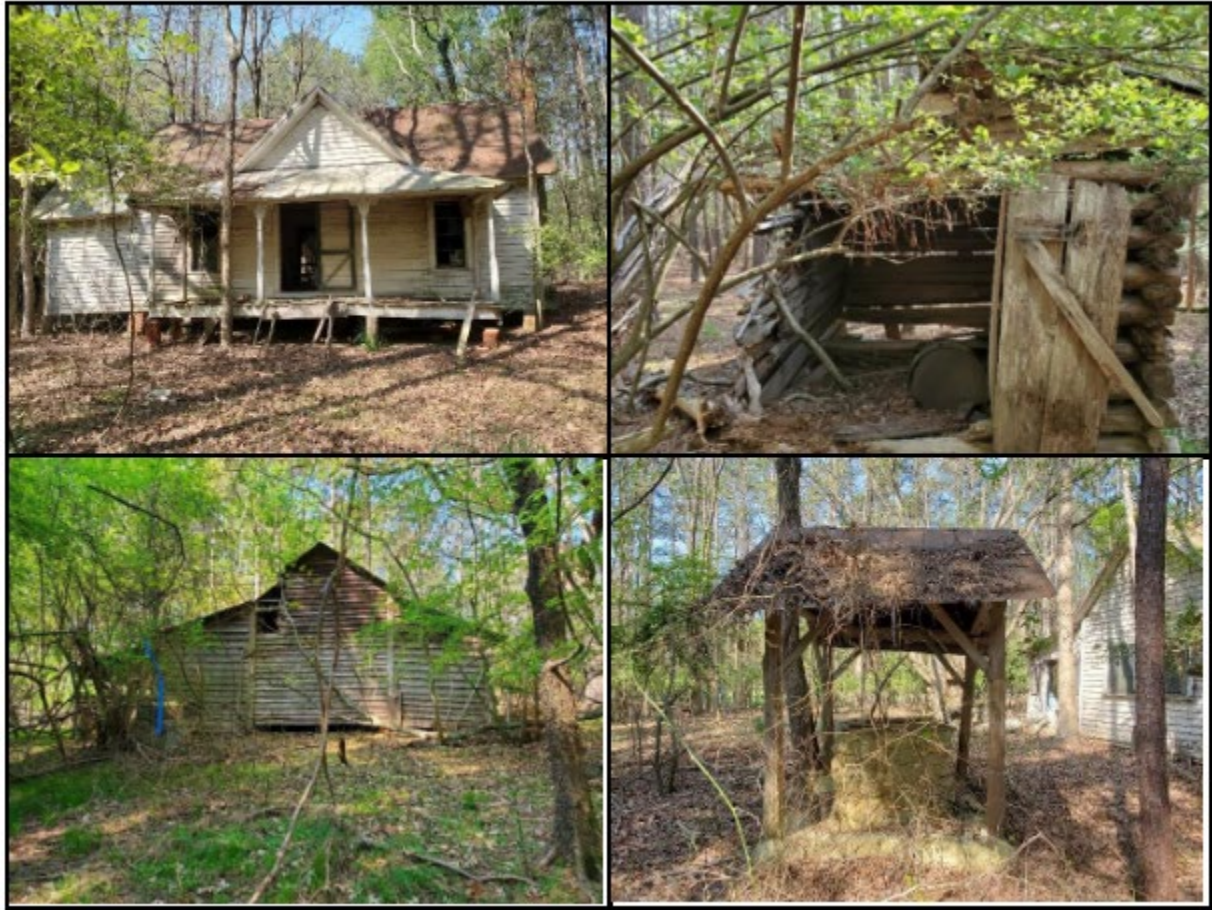
Figure 29 | Buildings at Site 31CH1366 (Top: Building 1, Building 2. Bottom: Building 4, Building 3)

While the house was constructed prior to 1890, the remaining buildings postdate 1890. The buildings are also not unique for farmsteads of this period. Due to these factors, this site is unlikely to yield new or significant data to our understanding of prehistoric or historic settlement in this area. It has fulfilled its research potential at this level of investigation and is recommended not eligible for NRHP (Archaeological Consultants of the Carolinas, Inc. July 2023).

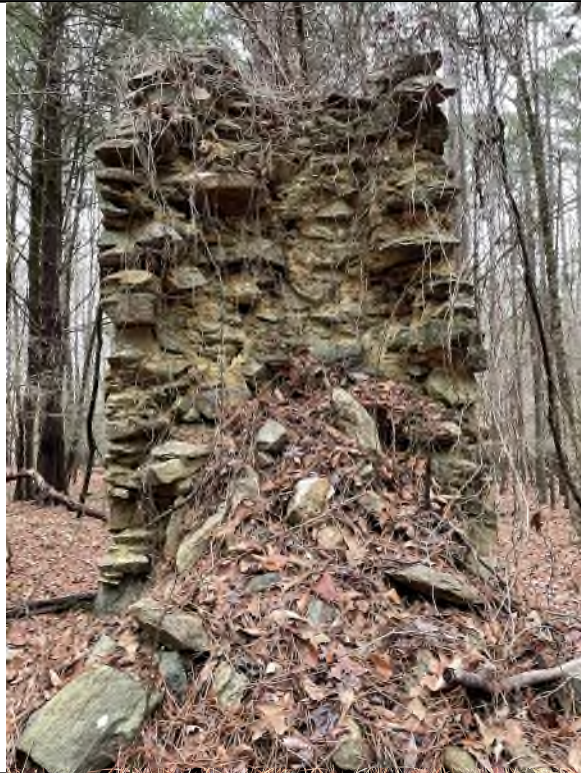
Photo No. 1

Date: 3/10/2022
Photographer: JSD
Notes: Remnants of a partially collapsed stone chimney.

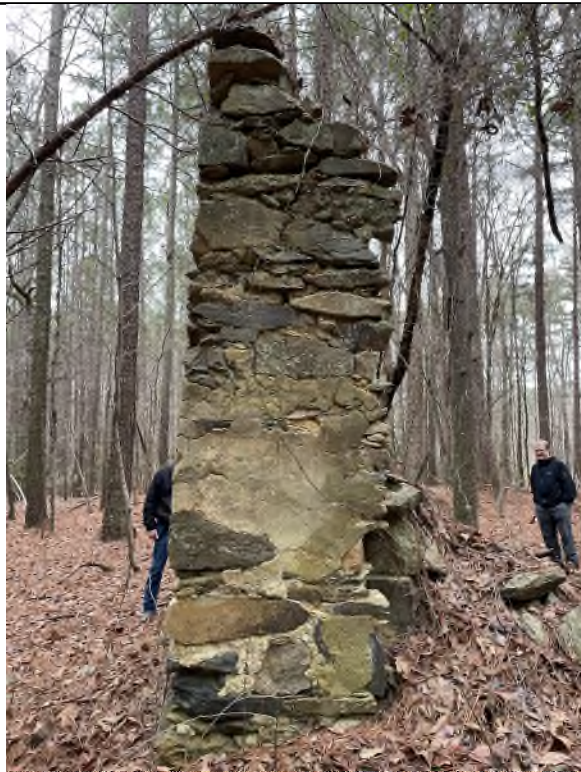
Photo No. 2

Date: 3/10/2022
Photographer: JSD
Notes: Remnants of a partially collapsed stone chimney.

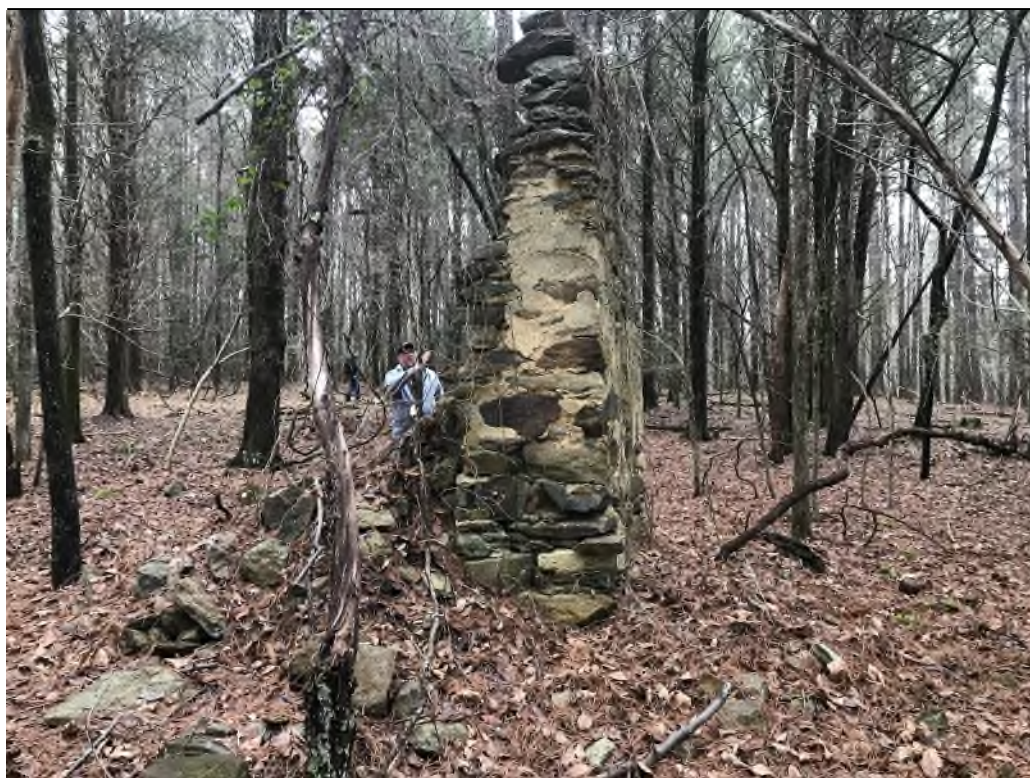
Photo No. 3

Notes: Remnants of a partially collapsed stone chimney.

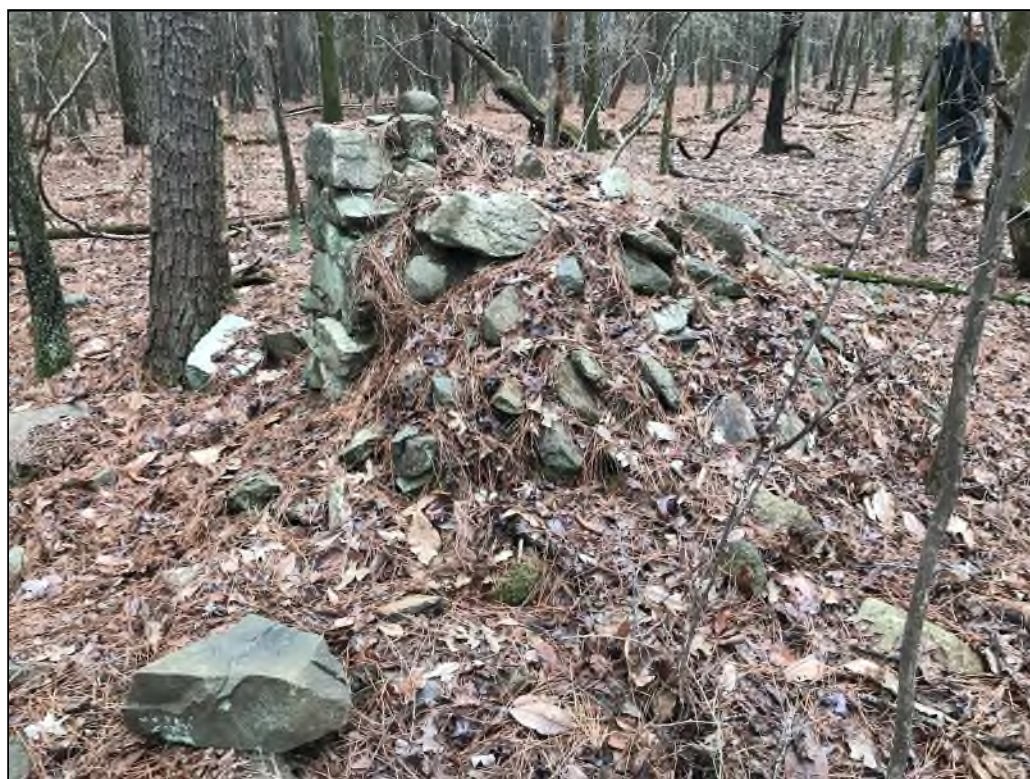
Photo No. 4

Notes: A large pile of stone observed on the opposite end of the structure.

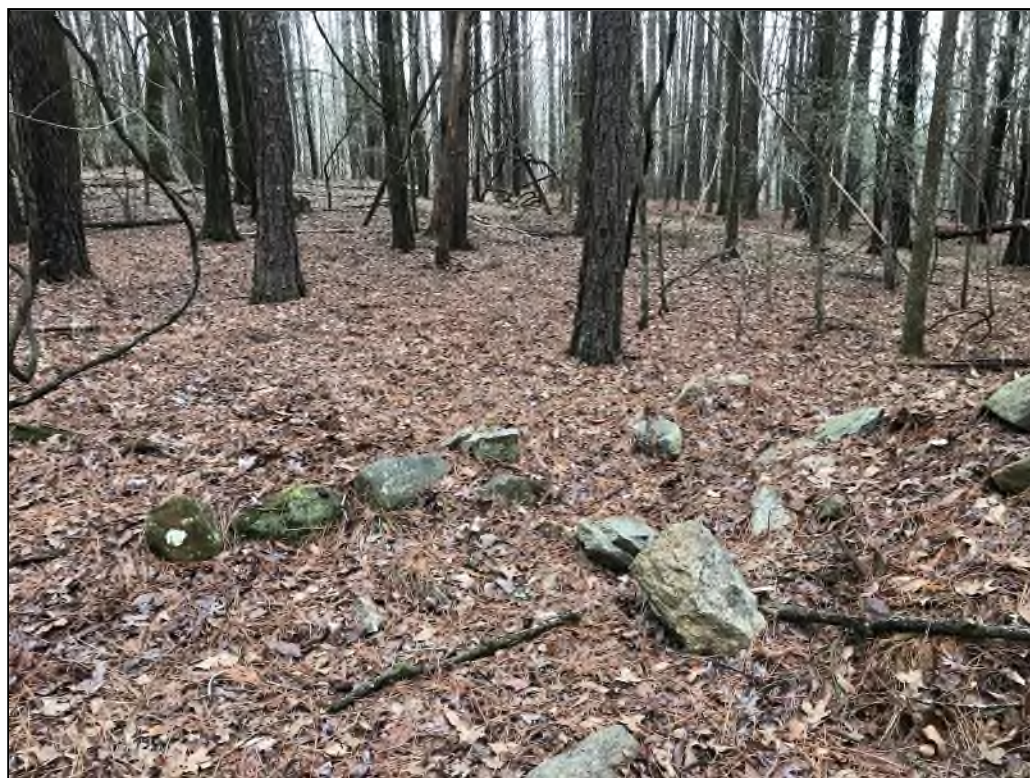
Photo No. 5

Notes: Foundation stones observed running between the chimney and the other stone structure.
